# Gamma-ray irradiation test of Electric components of rescue mobile robot Quince –Toward emergency response to nuclear accident at Fukushima Daiichi Nuclear Power Station on March 2011–

**Abstract** — On March 11, 2011, a massive earthquake and tsunami hit eastern Japan, particularly the Tohoku area. Since then, the Fukushima Daiichi Nuclear Power Station has been facing a crisis. To respond to this situation, we began a project to redesign our mobile robots for disaster response missions. A key issue to be addressed was to check the radiation hardness of the electric components of our robot. Initially, no information was available in this regard. Therefore, we conducted gamma-ray irradiation tests for the electric components using cobalt-60. In this paper, we introduce the procedure for the irradiation test and report the results of the test.

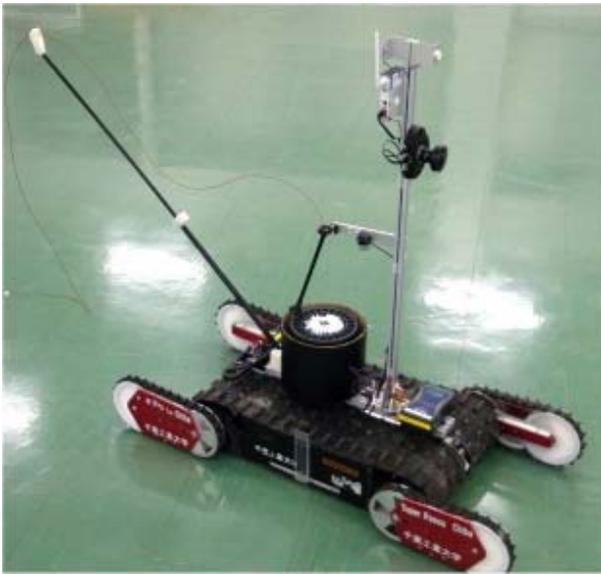
Fig. 1. Tracked vehicle Quince: Fukushima version.

Quince is a small, light weight 6 degrees-of-freedom tracked vehicle designed for the traversal of stairs, and rubble. It has four sub-tracks to negotiate uneven terrain. An overview of the robot (Redesign for Fukushima disaster response) is shown in Fig.1, and its major electric components are listed in Table II. Basically, these devices were irradiated by gamma-rays to check durability.

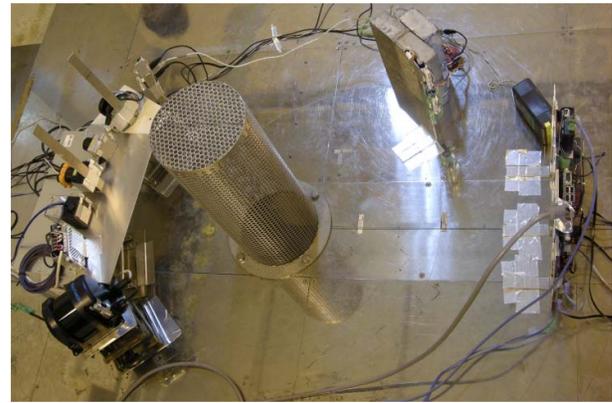
Fig. 3. Device configuration for gamma-ray irradiation test.

A photograph of the test-configuration on the second day is shown in Fig.3. Radiation sources are supposed to be placed in the cylindrical mesh at the center of the photograph. You can see that the CPU board at the right of the photograph is located at a place (0.66 m from the source) further than that for the sensors (0.45 m from the source). For all of the devices, we

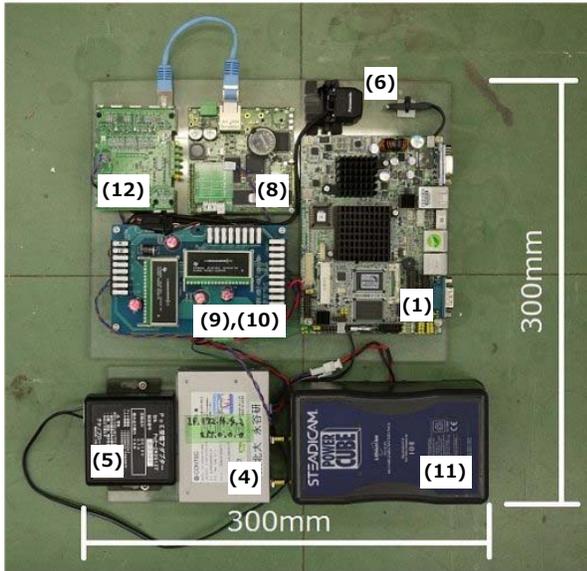
Fig. 2. CPU board with some electric devices and CCD camera.

Some of the numbers above correspond with the numbers in Fig.2.

In this test, we used Aminogray to confirm the total dose of each component. On the first day, we used three Aminograys attached at the left, center, and right of the test board, as shown in Fig.2. On the second day, we used a total of 12 Aminograys, which included those for sensors and additional devices. The total dose of each component is shown in Table III.

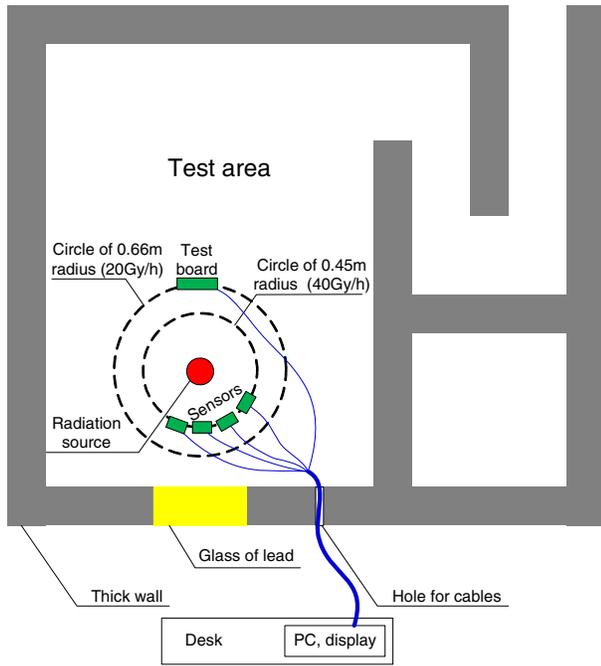
Fig. 4. Layout of devices and experimental facility.

placed the electric parts perpendicular to the source, so that the configuration of each device became the worst-case condition. Fig.4 shows the layout of the devices and the experimental facility (scale is not correct).

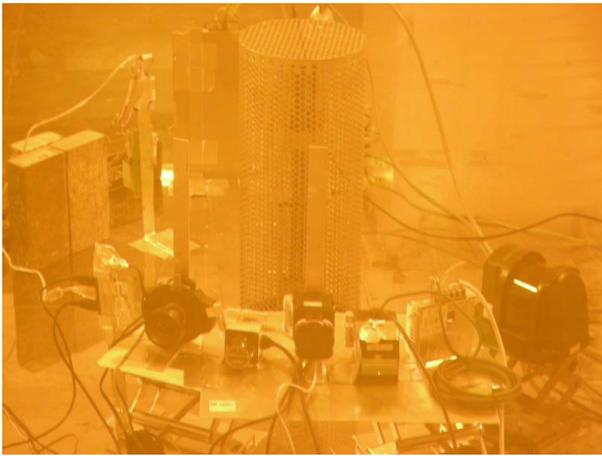
Fig. 5. Overview of gamma-ray irradiation test.

An overview of the test is shown in Fig.5. Because the photograph was taken through a thick piece of lead glass for radiation protection, the color became completely yellow. After 5 h, which meant as total dose of 100 Gy, all of the devices were still working fine. Of course, it is risky to conclude that conventional devices have a typical durability of 100 Gy, from the results of just one test. This is because devices have individual differences.
